# Stream Bank Stabilization Design for Urbanized Segment of the Whippany River Between Lake Pocahontas and the Railroad Crossing Town of Morristown, Morris County, NJ

# **Princeton Hydro, LLC**

October 2012

Princeton Hydro Project Number 0936.003

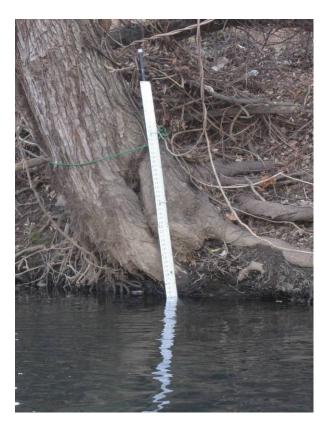
Figure 2: Staff Gauge

While onsite, a staff gauge and two (2) erosion pins were installed on the river right stream bank adjacent to the Bethel A.M.E. Church, as shown in Figures 1, 2, and 3. At the time of installation, the staff gauge was surveyed to have a zero elevation of 92.11 feet in the assumed datum and the reading on the gauge was 1.69 feet, thus the observed water surface elevation was 93.80 feet. The erosion pins were also surveyed and initial measurements from the end of the pin to the bank were taken. The upper pin was measured to be 6.5 inches extended from the bank and the lower pin at 7.5 inches extended from the bank. Erosion of the bank will result in greater exposure of the pins. It is anticipated that volunteers of the church and community will continue to monitor these devices and provide the information to Princeton Hydro. The collected data will be used to calibrate the data at the USGS gauge to the site and determine the rate of erosion of the bank.

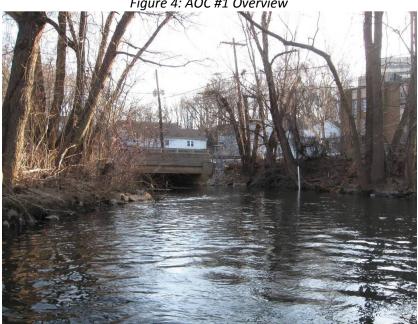
Figure 4: AOC #1 Overview

Area of concern (AOC) #1 is located along river right and extends approximately 60 feet upstream from the Center Street Bridge as shown in Figure 4. This area is adjacent to the Bethel A.M.E. Church and its access driveway. This bank is relatively steep with three (3) 24 inch plus diameter trees growing within the bank. There is also a utility pole near the edge of the sidewalk with wires extending through the trees to the church. The bridge abutment has riprap of about 4-8 inches in diameter to protect it from scour from both the stream and the 6 inch PVC pipe outfall located near the top of the bank, as seen in Figure 5. This pipe is assumed to be connected to roof leaders.

The erosion of the banks is expected to be caused by the fluctuations in the water surface elevation created by the backwater from the bridge. Thus the velocities would be relatively low and banks and floodplains can be re-graded, stabilized with vegetation and a boulder toe similar to the detail shown in Figure 6. In addition, the three (3) trees shown in Figure 7 will be cut flush with the bank so the stumps may remain for added stabilization. The boulder toe could be created from the stone retaining wall removed along river left just upstream.

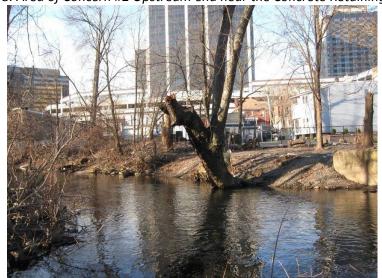
Figure 8: Area of Concern #2 Upstream end near the Concrete Retaining Wall.

Area of Concern #2 is a continuation of Area of Concern #1, extending to the concrete retaining wall as shown in Figure 8. This area extends through a number of properties including ones owned by Bethel A.M.E. Church, the Township of Morristown, and other private parties. AOC #2 is characterized by bare jagged banks with fences hanging into stream, see Figure 9. The fences are collecting debris during high flows and decreasing flowable area.

The banks included within AOC #2 are anticipated to be stabilized in a similar manor as AOC #1 and Figure 6 above. As shown on Sheet 1 of 3 of the attached plans, tree 4 shall remain as the tree roots protect a large portion of the bank, as seen is Figure 10. The up slope side of the tree is anticipated to be used as a reference elevation for grading back the bank.

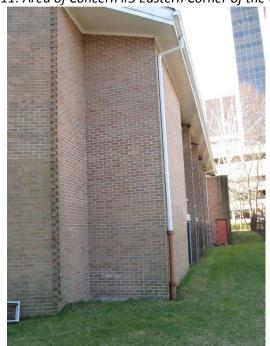
Figure 11: Area of Concern #3 Eastern Corner of the Church

Area of Concern #3 is located on the grounds of the Bethel A.M.E. Church located off the eastern rear corner of the building (Figure 11), near the end of the paved accessway (Figure 12).

It is proposed to disconnect the roof leaders from the building and have them discharge into a rain garden similar to the design shown in Figure 13. It is assumed that groundwater will be close to the expected bottom elevation of the rain garden and/or that soil conditions not suitable for infiltration will

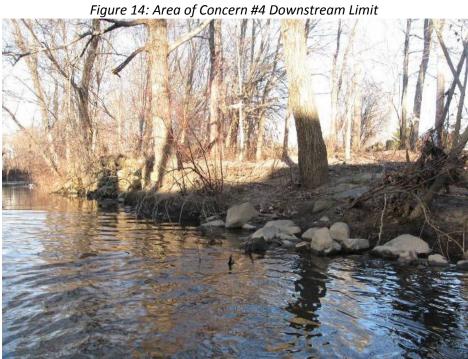
Figure 15: Area of Concern #4 Wooded Stream Corridor Looking Upstream

Area of Concern #4 is located on river left opposite AOC #2 and on property owned by Town of Morristown. The property includes a small parking lot outlined with wooden bollards, and is wooded along the stream bank and grassed along the remaining areas; refer to Figures 14 through 17.

It is proposed to excavate the grassed area to the elevation similar to the bank, creating more floodplain at a lower elevation as shown in Figure 18 below. This will be created with varied micro-topography to increase habitat diversity. In addition, the stone retaining wall, as shown in Figure 19, shall be removed and used for toe protection in AOC #1 and #2. The purpose of the concrete and stone access ramp shown in Figure 20 is unknown. The ramp is proposed to be removed and, to increase awareness and appreciation for the environment, public access to the stream will be maintained here in a manner that does not obstruct flow as the ramp currently does.

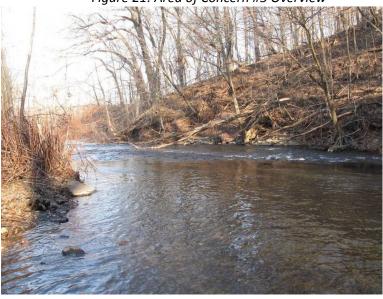
Figure 21: Area of Concern #5 Overview

Area of Concern #5 is located along the bend between the Center Street Bridge and the railroad bridge. This area is characterized as transverse bar which is directing flows into the high, steep banks. These banks are sloughing into the stream. Figures 21 through 23 depict the main characteristics of this stream corridor.

The eroded slopes and adjacent areas will have bank stabilization measures with a boulder toe, similar to Figure 24. In addition, It is proposed to install a redirection feature such as a weir within the stream to direct flows away from the banks, similar to Figure 25.

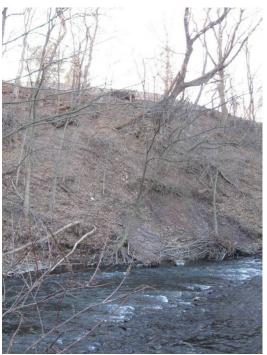
Figure 22: Area of Concern #5 Steep Slopes and Bank Sloughing

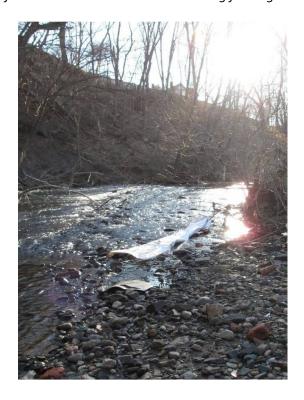
Figure 23: Area of Concern #5 Transverse Bar directing flow against sloughing bank.

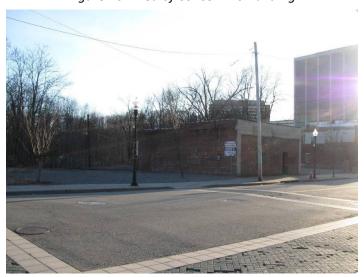
Figure 26: Area of Concern #6 Building

Area of Concern #6 is located at the intersection of Martin Luther King Avenue and Flagler Street along the river right bank downstream of the Martin Luther King Avenue stream crossing. The property is currently for sale by owner and the building is shown in Figure 26 and the concrete channel shown is Figure 27. The property is mostly gravel with very little vegetation, as seen is Figure 28.

It is proposed to acquire the property and excavate the area creating a floodplain at a lower elevation, allowing for water backing up from the downstream crossings to be temporarily stored, as illustrated in Figure 18 above. The floodplain will be created with varied micro-topography increasing habitat diversity.

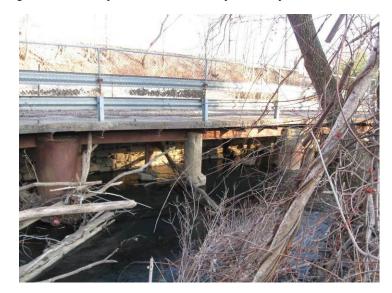
Figure 29: Area of Concern #7 View of the Platform and Columns

Area of Concern #7 is located upstream of Martin Luther King Avenue along river left, across the Whippany River from the baseball field. The bank and a portion of the stream are covered by a concrete platform. This platform is held up by series of columns and supports that are situated in the channel and reduce active flow area (see Figure 29). As can be seen in Figure 30 below, the platform extends over the channel as it meanders toward the Martin Luther King Avenue crossing. The most upstream extend of the platform and its columns have collapsed (see Figure 31).

It is proposed to remove the platform, columns, supports and all other associated structures, including as much of the retaining wall as possible. These features are creating a constriction of flow and their removal will be beneficial to flow and the recreational use of Patriots Path. It is proposed to stabilize the banks with a rock toe, geotextile wraps, and vegetation as shown in Figure 32. The earthen bank will provide increased ecological benefit to the riparian area and increase the flowable area during high flows.
