# Stream Bank Stabilization Design for Urbanized Segment of the Whippany River Between Lake Pocahontas and the Railroad Crossing Town of Morristown, Morris County, NJ

# **Princeton Hydro, LLC**

October 2012

Princeton Hydro Project Number 0936.003

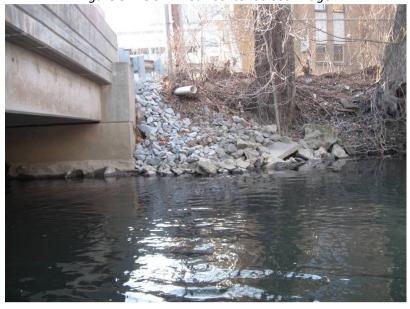
Area of concern (AOC) #1 is located along river right and extends approximately 60 feet upstream from the Center Street Bridge as shown in Figure 4. This area is adjacent to the Bethel A.M.E. Church and its access driveway. This bank is relatively steep with three (3) 24 inch plus diameter trees growing within the bank. There is also a utility pole near the edge of the sidewalk with wires extending through the trees to the church. The bridge abutment has riprap of about 4-8 inches in diameter to protect it from scour from both the stream and the 6 inch PVC pipe outfall located near the top of the bank, as seen in Figure 5. This pipe is assumed to be connected to roof leaders.

Figure 4: AOC #1 Overview

The erosion of the banks is expected to be caused by the fluctuations in the water surface elevation created by the backwater from the bridge. Thus the velocities would be relatively low and banks and floodplains can be re-graded, stabilized with vegetation and a boulder toe similar to the detail shown in Figure 6. In addition, the three (3) trees shown in Figure 7 will be cut flush with the bank so the stumps may remain for added stabilization. The boulder toe could be created from the stone retaining wall removed along river left just upstream.

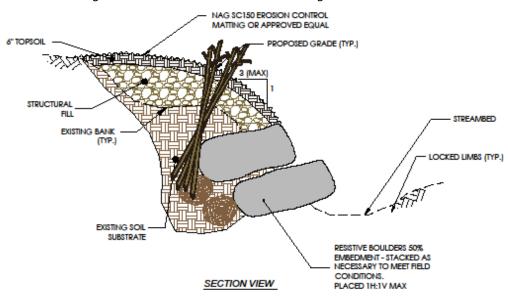
Figure 6: Bank Stabilization with Grading and Boulder Toe

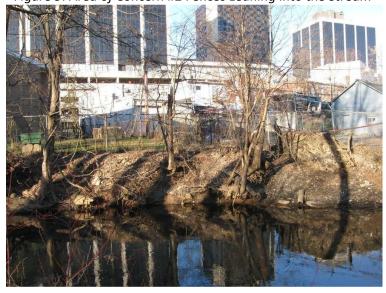
Area of Concern #2 is a continuation of Area of Concern #1, extending to the concrete retaining wall as shown in Figure 8. This area extends through a number of properties including ones owned by Bethel A.M.E. Church, the Township of Morristown, and other private parties. AOC #2 is characterized by bare jagged banks with fences hanging into stream, see Figure 9. The fences are collecting debris during high flows and decreasing flowable area.

Figure 8: Area of Concern #2 Upstream end near the Concrete Retaining Wall.

The banks included within AOC #2 are anticipated to be stabilized in a similar manor as AOC #1 and Figure 6 above. As shown on Sheet 1 of 3 of the attached plans, tree 4 shall remain as the tree roots protect a large portion of the bank, as seen is Figure 10. The up slope side of the tree is anticipated to be used as a reference elevation for grading back the bank.

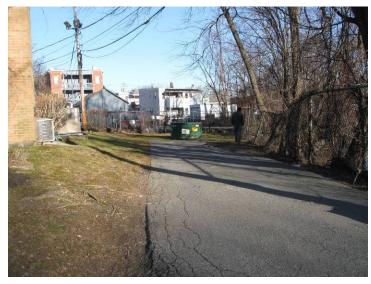
Area of Concern #3 is located on the grounds of the Bethel A.M.E. Church located off the eastern rear corner of the building (Figure 11), near the end of the paved accessway (Figure 12).

Figure 11: Area of Concern #3 Eastern Corner of the Church

It is proposed to disconnect the roof leaders from the building and have them discharge into a rain garden similar to the design shown in Figure 13. It is assumed that groundwater will be close to the expected bottom elevation of the rain garden and/or that soil conditions not suitable for infiltration will

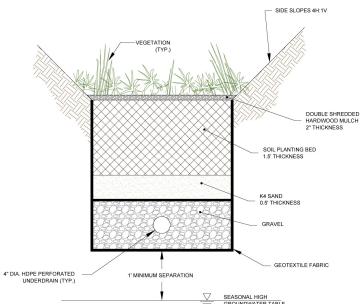
Figure 13: Rain Garden Detail

be encountered, thus the system will need to be lined with geotextile fabric and under drained. Rain gardens will provide water quality treatment and water retention for the runoff entering the system.

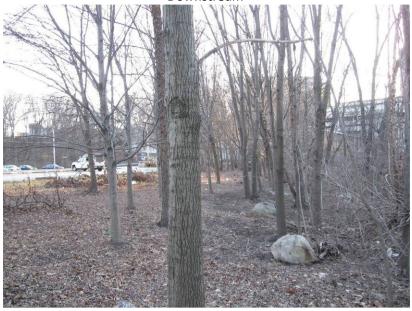
Figure 17: Area of Concern #4 Wooded Stream Corridor, Grassed Area and Parking Lot Looking

Downstream

It is proposed to excavate the grassed area to the elevation similar to the bank, creating more floodplain at a lower elevation as shown in Figure 18 below. This will be created with varied micro-topography to increase habitat diversity. In addition, the stone retaining wall, as shown in Figure 19, shall be removed and used for toe protection in AOC #1 and #2. The purpose of the concrete and stone access ramp shown in Figure 20 is unknown. The ramp is proposed to be removed and, to increase awareness and appreciation for the environment, public access to the stream will be maintained here in a manner that does not obstruct flow as the ramp currently does.

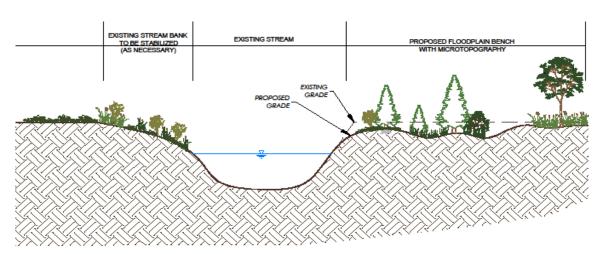
Figure 18: Area of Concern #4 Floodplain Creation

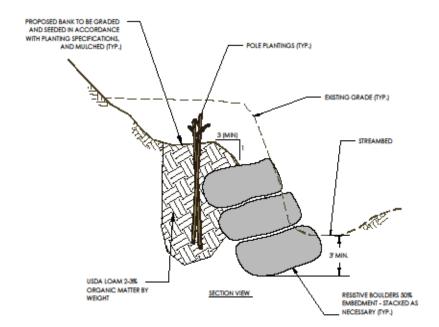
Figure 24: Area of Concern #5 Proposed Stabilization Detail

The eroded slopes and adjacent areas will have bank stabilization measures with a boulder toe, similar to Figure 24. In addition, It is proposed to install a redirection feature such as a weir within the stream to direct flows away from the banks, similar to Figure 25.

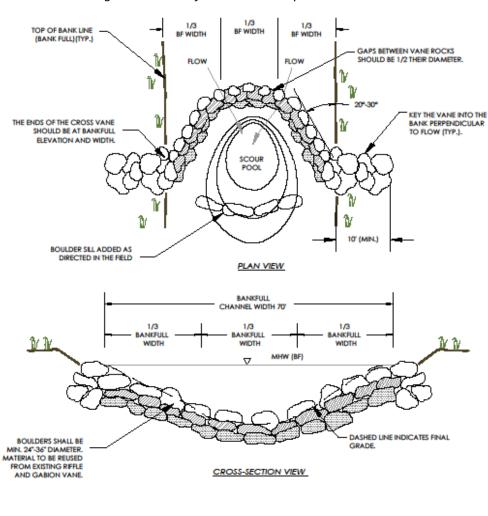
Figure 25: Area of Concern #5 Proposed Weir Detail

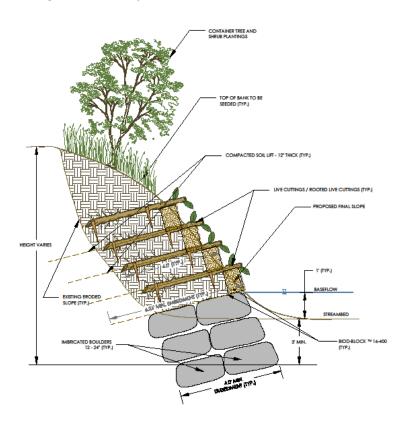
Figure 32: Area of Concern #7 Bank Stabilization

It is proposed to remove the platform, columns, supports and all other associated structures, including as much of the retaining wall as possible. These features are creating a constriction of flow and their removal will be beneficial to flow and the recreational use of Patriots Path. It is proposed to stabilize the banks with a rock toe, geotextile wraps, and vegetation as shown in Figure 32. The earthen bank will provide increased ecological benefit to the riparian area and increase the flowable area during high flows.

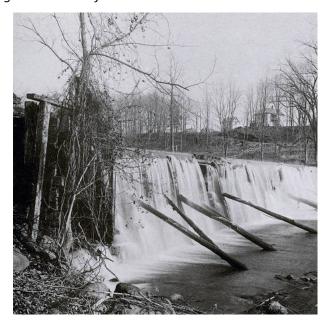
Area of Concern #8 refers to Lake Pocahontas and the dam that creates it. The dam is owned and operated by Town of Morristown and according to the June 1995 *Improvements to Pocahontas Dam Report* as prepared by O'Brien & Gere Engineering, the dam is in need of some repair. Figures 33 and 34 depict the dam at different time periods. A cross-section and a plan view of the spillway are shown below in Figures 35 and 36 as provided by O'Brien and Gere Engineering.

Figure 33: Area of Concern #8 Current Pocahontas Dam<sup>1</sup>

It is proposed to notch the existing concrete spillway in a way to pass baseflow and to store water during storm events. This method of notching will use the current impoundment to store flood flows and slowly release them, ultimately reducing downstream flooding. The channel restored through the

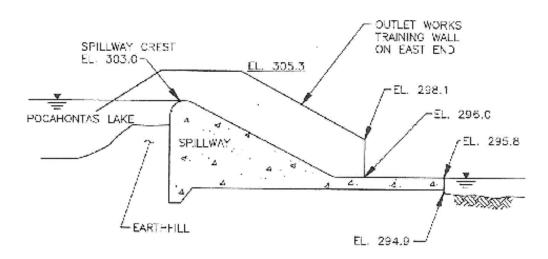
Figure 35: Area of Concern #8 Dam Cross-Section<sup>2</sup>

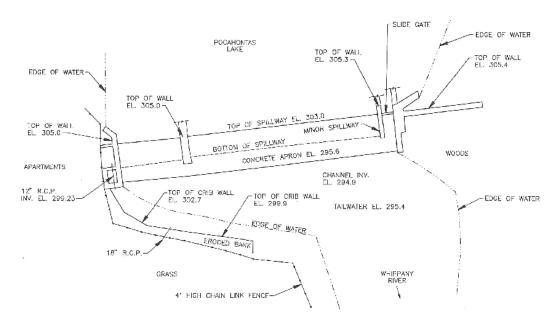
Figure 36: Area of Concern #8 Plan View of Dam
